TD-05-032
10/05

EDDY CURRENT SCANNING REPORT

FNAL-3RDHARMONIC CAVITIES #3-6

FNAL/Technical Division

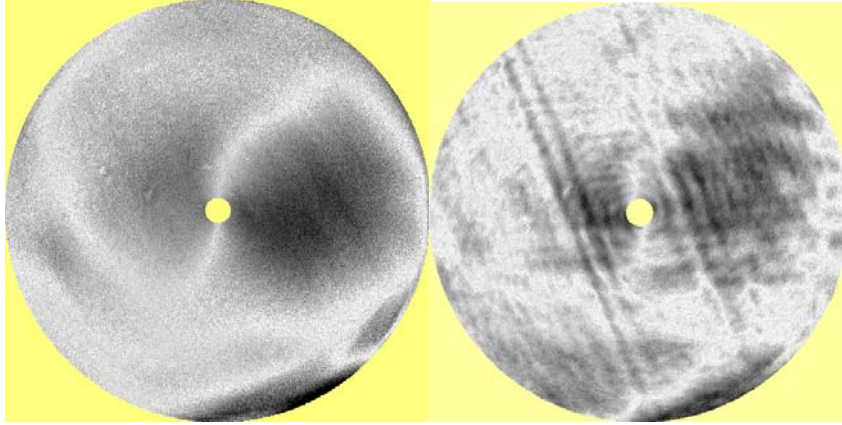
Figure 4 shows the results of eddy current scans performed with the SNS/FNAL scanner on disc 14 before and after removing 175 μm with BCP etching. The plots clearly show a change of appearance of the scan, possibly a result of the increase of surface roughness due to the BCP etching. Also, and this is corroborated by simple visual inspection, most defects are still present after etching. This result indicates that the defects found in some blanks from this batch will not be removed by the subsequent etching steps and that these particular disc-sides should not be used for the inside of the cavities.

Figure 4: Scan of disc 14/2 before (left) and after (right) 175 μm were removed with BCP etching.

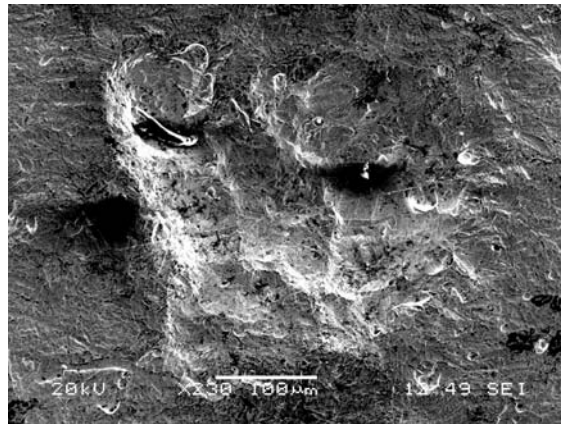
A chemical analysis with EDX of the first micron of the crater-lining surface in the pit of disc 134 (side 2) revealed no difference to the rest of the surface. Figure 5 shows an SEM image of this (shallow) pit.

Figure 5: SEM pic of surface pit in disc 134-side 2.
